DESIGN PARAMETERS OF ROOF SUPPORT SYSTEMS FOR PRE-DRIVEN LONGWALL RECOVERY ROOMS

**S. C. Tadolini
T. M. Barczak**
NIOSH
Pittsburgh, PA

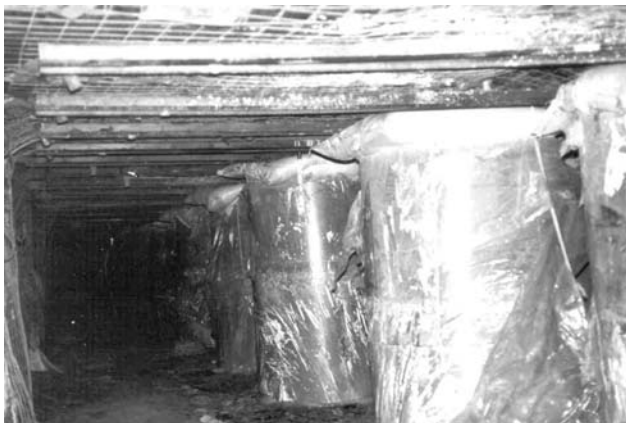
Figure 6. Photograph of completed cribs, roof supports, and instrumentation.

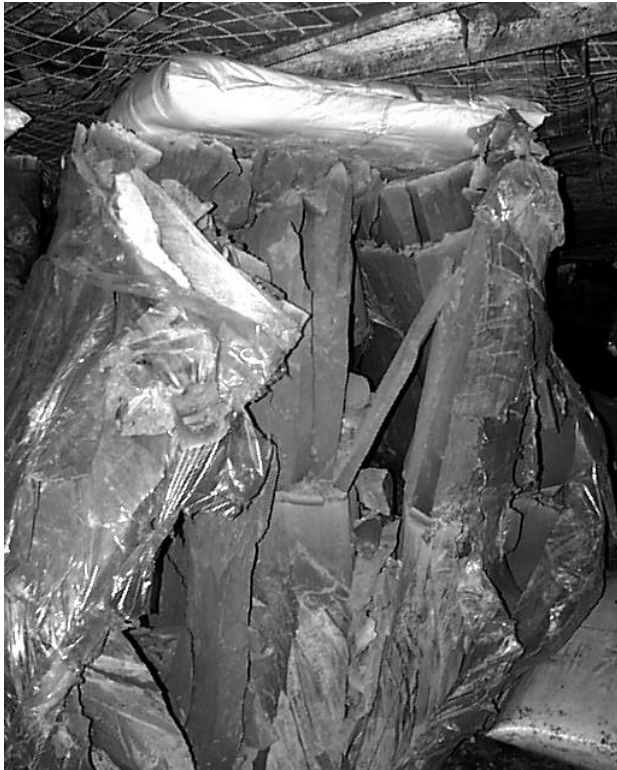
Figure 7. Brittle crib failure prior to the longwall entering the recovery room.

The greatest measured crib load was approximately 1,000,000 lbs. This load, coupled with the crib displacements, results in a stiffness calculation for the concrete crib and the bag of 1.69×10^6 lb/inch. This value is significant because it represents an indication of the resistance to load. While this stiffness helped minimize roof closure and movement, the stiff material

properties may have caused the cribs to fail in a brittle mode as shown in Figure 7.
